## Iran is Rapidly Reconstructing Taleghan 2

By David Albright, Sarah Burkhard, Spencer Faragasso, and the Good ISIS Team

September 17, 2026

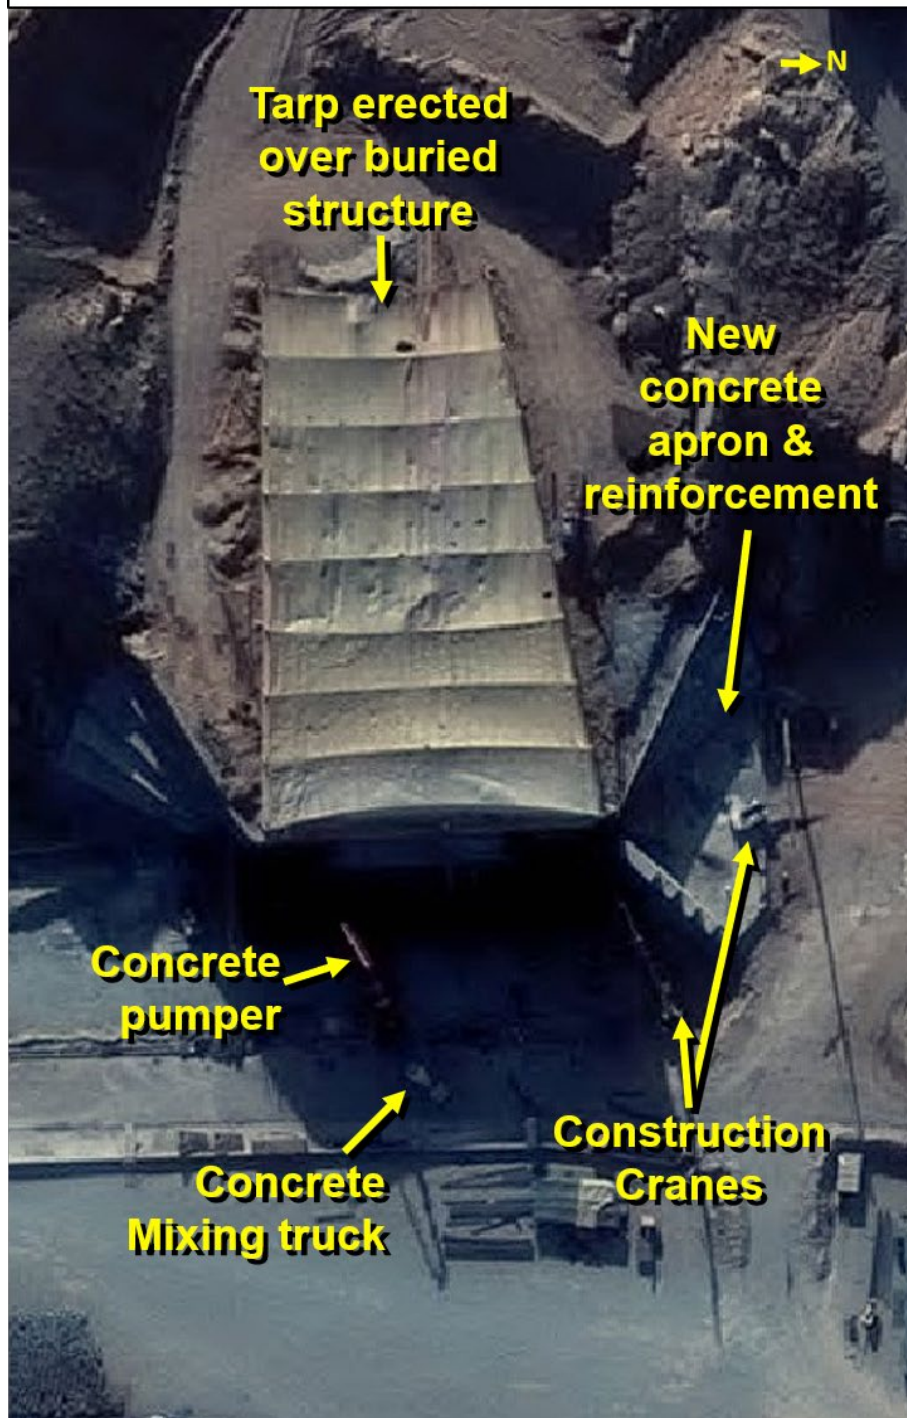
**Figure 1.** A close-up view of the reconstruction activities at Taleghan 2.

Vantor Technologies satellite imagery from September 13, 2026, shows that Iran is rapidly moving forward with the reconstruction of the Taleghan 2 facility located at the Parchin military complex. Iran has erected a tarp above the destroyed hardened buried facility, hiding the reconstruction activity that is occurring underneath from satellite view or aerial reconnaissance (see Figure 1). Significant activity can be seen throughout the construction site. Construction vehicles, including dump trucks, bulldozers, concrete pump trucks and concrete mixers, and cranes, are actively working to rebuild the facility (see Figure 2). Repair and rehabilitation work began in June 2026, first with Iran repairing and placing concrete caps over the penetration holes caused by the multiple bunker buster weapons dropped on the facility.<sup>1</sup> Iran has also built a new concrete apron reinforcement on the right side of the facility, the one on the left side that we noted in our July 2026 update now appears complete. This will provide additional blast protection from an aerial attack.

The facility has been attacked twice: first in October 2024, then after having been rebuilt from May 2025 as a hardened buried facility, it was attacked again in early March 2026.<sup>2</sup> The second attack saw the use of multiple bunker buster weapons against the facility, blowing out the internal structure and causing surrounding structures to collapse. During its reconstruction starting in May 2025, the Institute observed the installation of a cylindrical structure, which may have been a high explosive containment vessel. Given the precision of the March 2026 attacks, the high explosive containment vessel was likely destroyed.

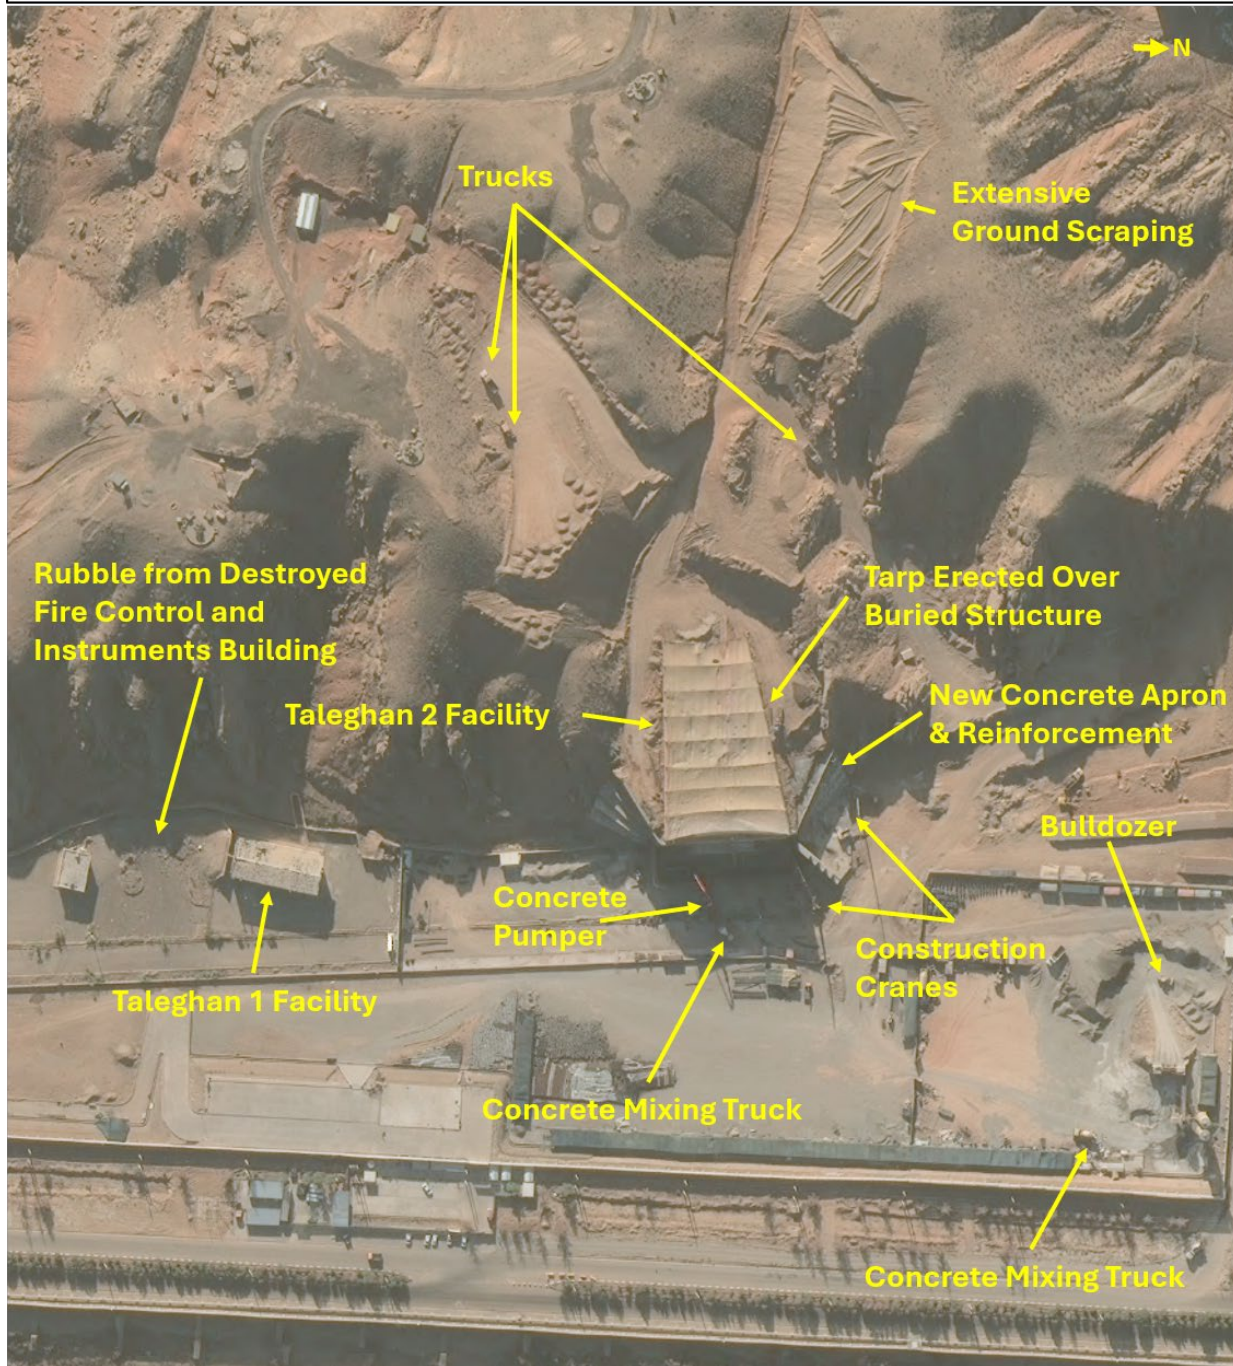
**Figure 2.** An overview of the construction site at Taleghan 2, showing significant activity throughout the site.
